**5<sup>th</sup> International Ankiros Foundry Congress**  
**5. Uluslararası Ankiros Döküm Kongresi**

# **DUCTILE IRON PIPE SURFACE CHARACTERIZATION AND PINHOLE FORMATION**

**Prof. Dr. Fevzi YILMAZ,  
Özgür CEVHER (M.Sc.) and Mustafa BAYRAKTAR (M.Sc.)**

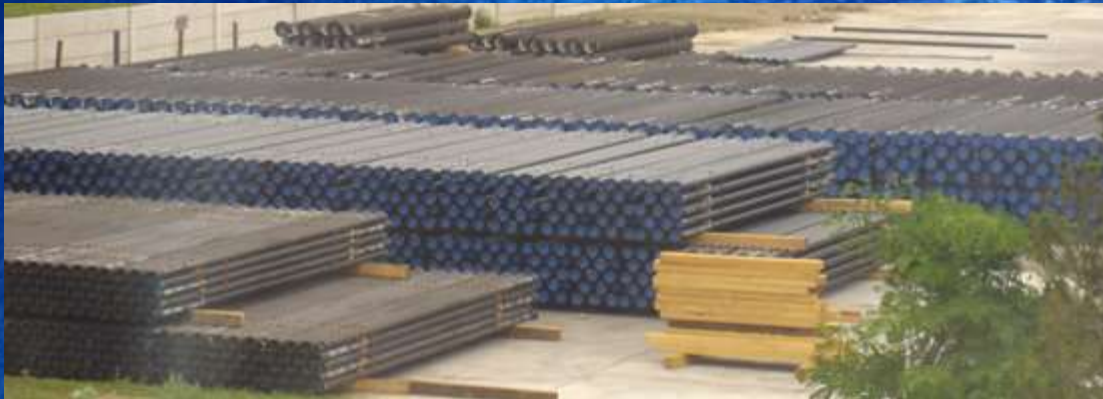
**Ductile iron pipes: c) DIPs at site d) Ductile iron pipe cross section micro structure after annealing treatment (Optical).**

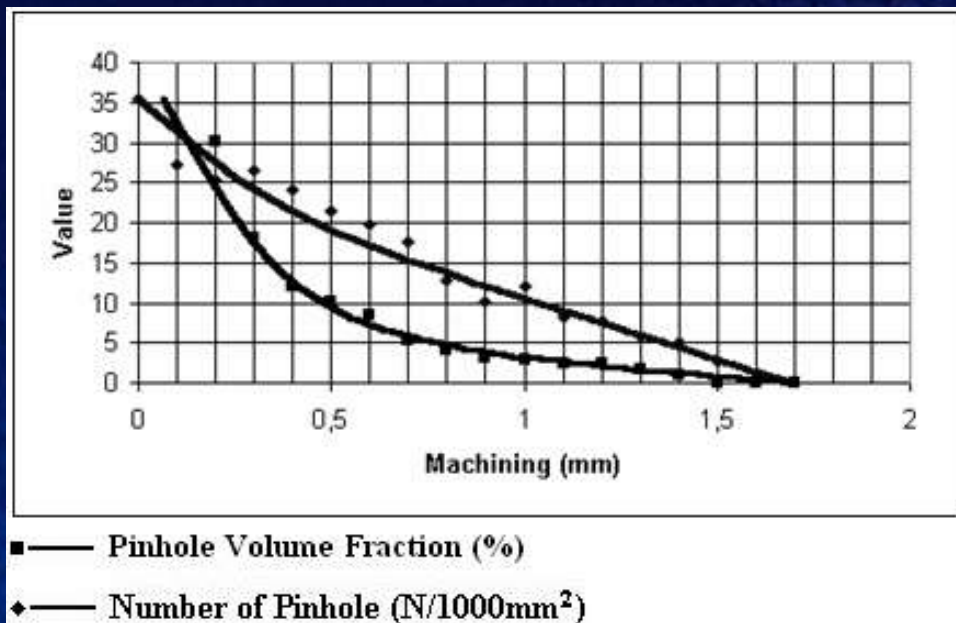
**Changing the number and volume fraction of pinholes with machining depth from the surface.**

- Gradual decrease of number of pinholes with depth is understandable. Step reduction of volume ratio with depth implies conical shape of pinholes as sketched in figure.
